# **#90-335-6A: ENG. NO START AFTER EXTENDED STORAGE (VITON HOSE KIT) - (Aug 15, 1990)**

**Subject: ENGINE NO START AFTER EXTENDED STORAGE**

**Model and Year: 1990 TRUCKS WITH FUEL INJECTION AND 2.5L, 2.8L, 4.3L, 5.0L, 5.7L, 7.4L ENGINE**

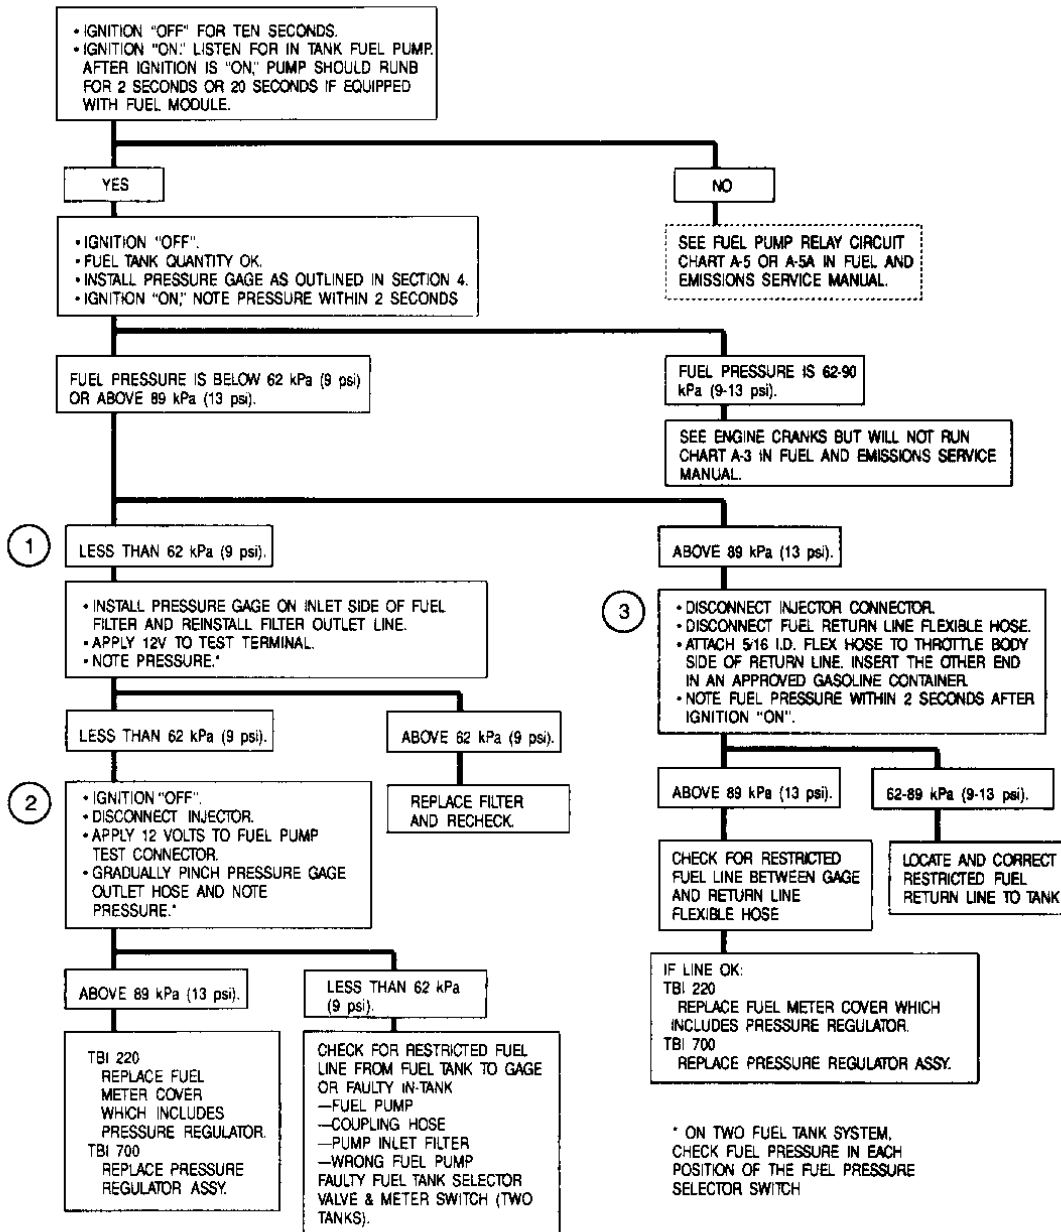
FIGURE 1

See fuel system pressure test (see Figure 1).

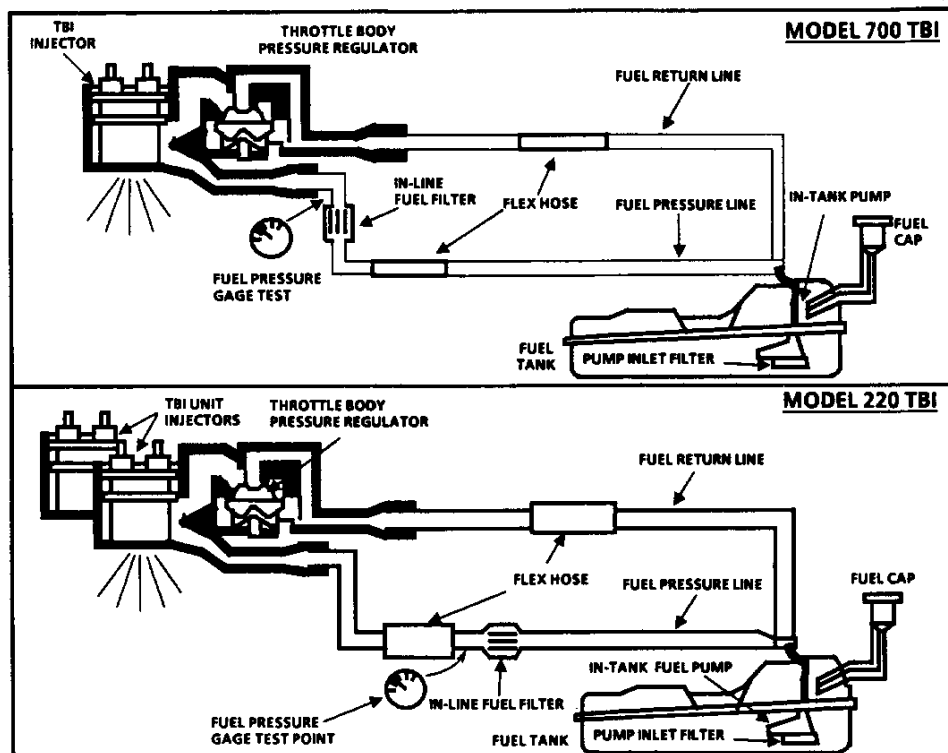
Figure 2

Some 1985-90 light trucks equipped with throttle body injection (TBI) engines (see list below) may experience a condition where fuel delivery to the engine is interrupted causing a no start. This condition may be caused by deterioration of the in-tank fuel pump coupler hose located between the sending unit assembly and the fuel pump. The deterioration is caused by prolonged high ambient temperatures in combination with low fuel volumes (or stale fuel) and extended vehicle storage.

Vehicles that are diagnosed as exhibiting this condition may be repaired by replacing the original coupler hose (see Figure 2) with a new Viton coupler hose kit, P/N 25028041. The kit consists of a new Viton hose and two clamps.
