#89-260-6A: SERPENTINE BELT W/WORN IDLER PULLEY OR TENSIONER - (Aug 31, 1989)

Model and Year: 1987-89 C, K, R, V, S, T TRUCKS AND M, G VANS WITH 4.3L, 5.0L, 5.7L, 7.4L (VIN CODE Z, H, K, N) ENGINES

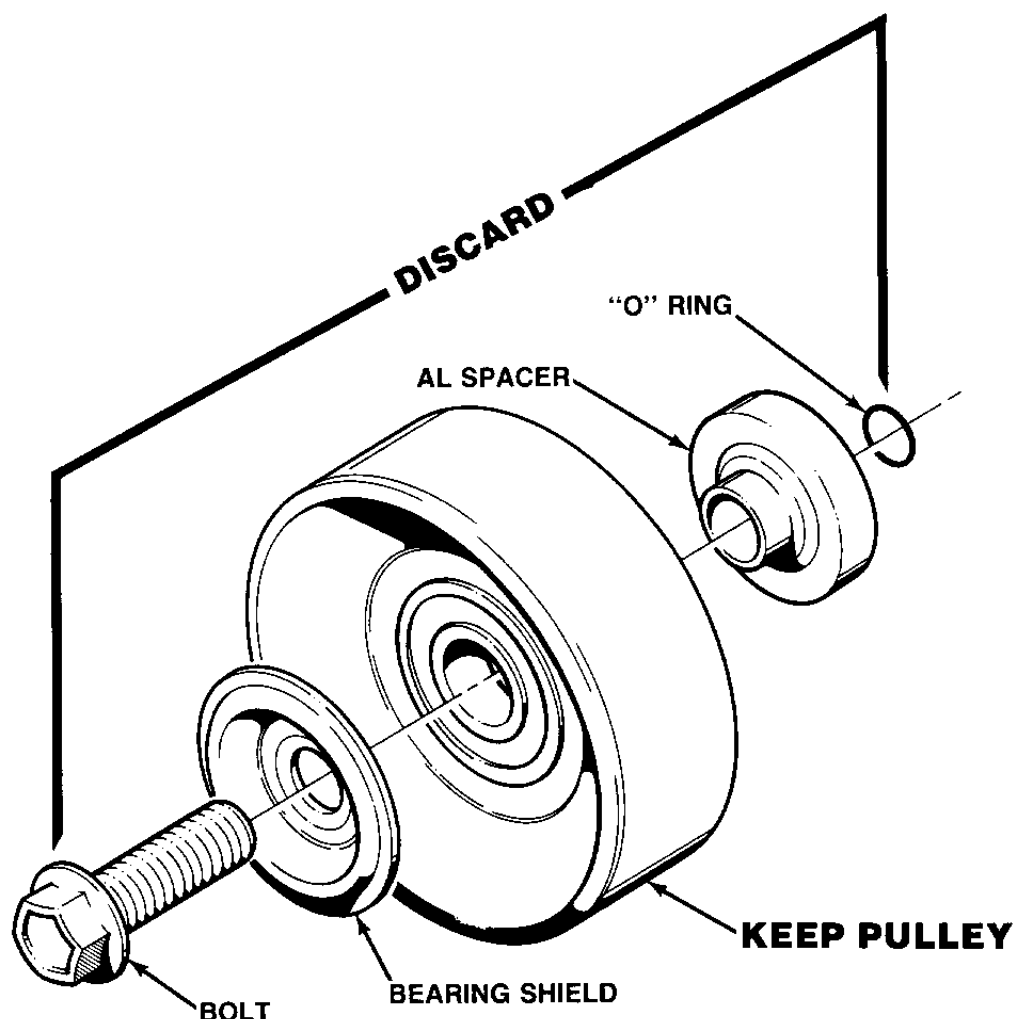
[Figure 1](#)

Some 1987-89 light-duty trucks with 4.3L, 5.0L, 5.7L, and 7.4L engines and equipped with serpentine belt drive may experience a condition where the belt becomes loose and squeals or the belt may come off the engine drive pulleys. This condition may be caused by a worn idler and/or worn belt tensioner pulley (plastic).

10129561 IDLER PULLEY ASM.

1. Using procedures in 6B-Engine Cooling, remove and discard the serpentine belt.
2. On trucks with 4.3L, 5.0L, 5.7L and 7.4L engines, using metal pulley (P/N 10129561) perform the following steps:
 - A. Remove O-ring, aluminum spacer, bolt, and metal bearing shield and discard (see illustration).
 - B. Retain the metal pulley.
3. With tensioner on engine, remove worn tensioner pulley, bolt, and metal bearing shield. Discard pulley and retain bolt and shield for reassembly.

IMPORTANT: 4.3L, 5.0L, and 5.7L bolt have left-hand threads.

7.4L bolt has right-hand threads.

4. Install new metal pulley and the original shield and bolt on the tensioner.
5. Install new serpentine belt.
