This page is to help our customers who have purchased a rebuild kit to rebuild their own TH400 using the same parts, techniques, and principles we use at Jake's Performance.

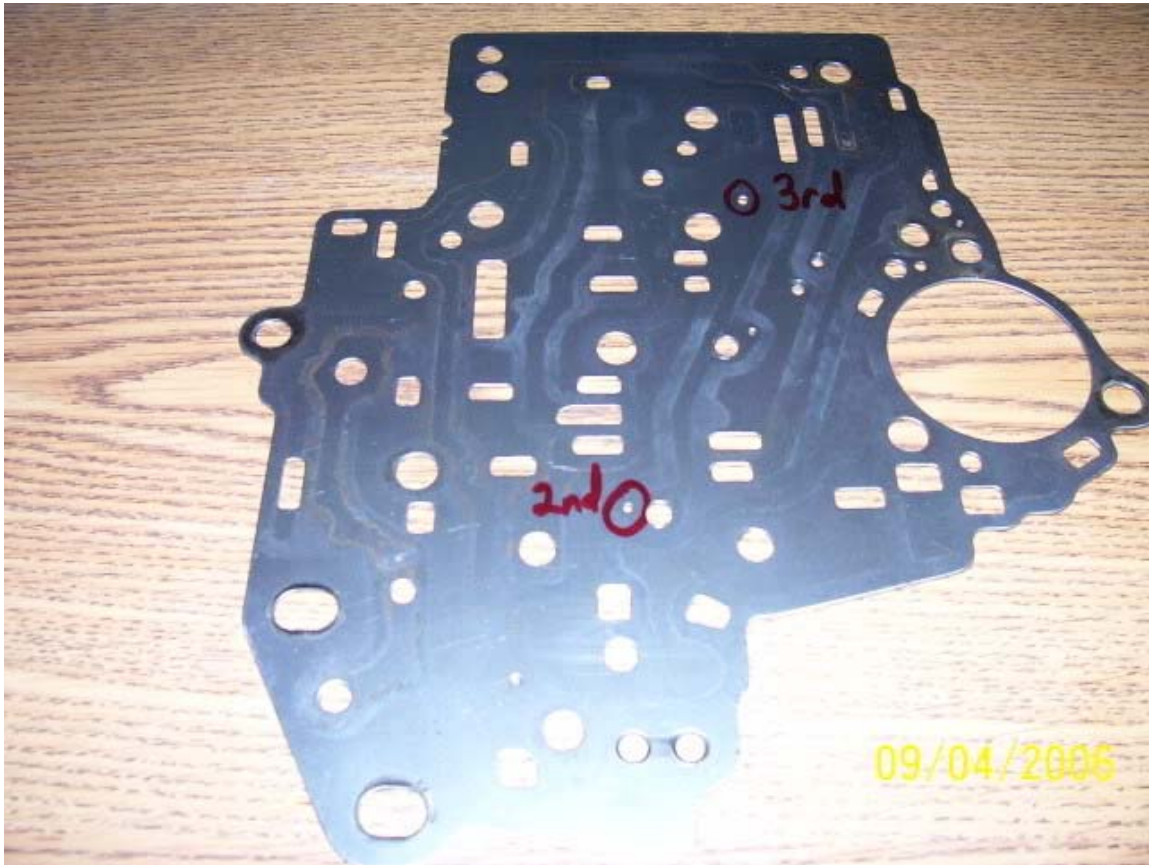
Pictured below is a TH400 separator plate. The feed holes are marked. These holes can be drilled larger for firmer shifts.

Our maximum recommended sizing is .125" for the 2nd feed and .140" for the 3rd feed. This prevents 2nd gear sprag failure and overly harsh part throttle shifts. On milder units, you can go smaller for comfort.

A .090" 2nd feed and .110" 3rd while maintaining the accumulator is a good compromise for towing or near stock applications.

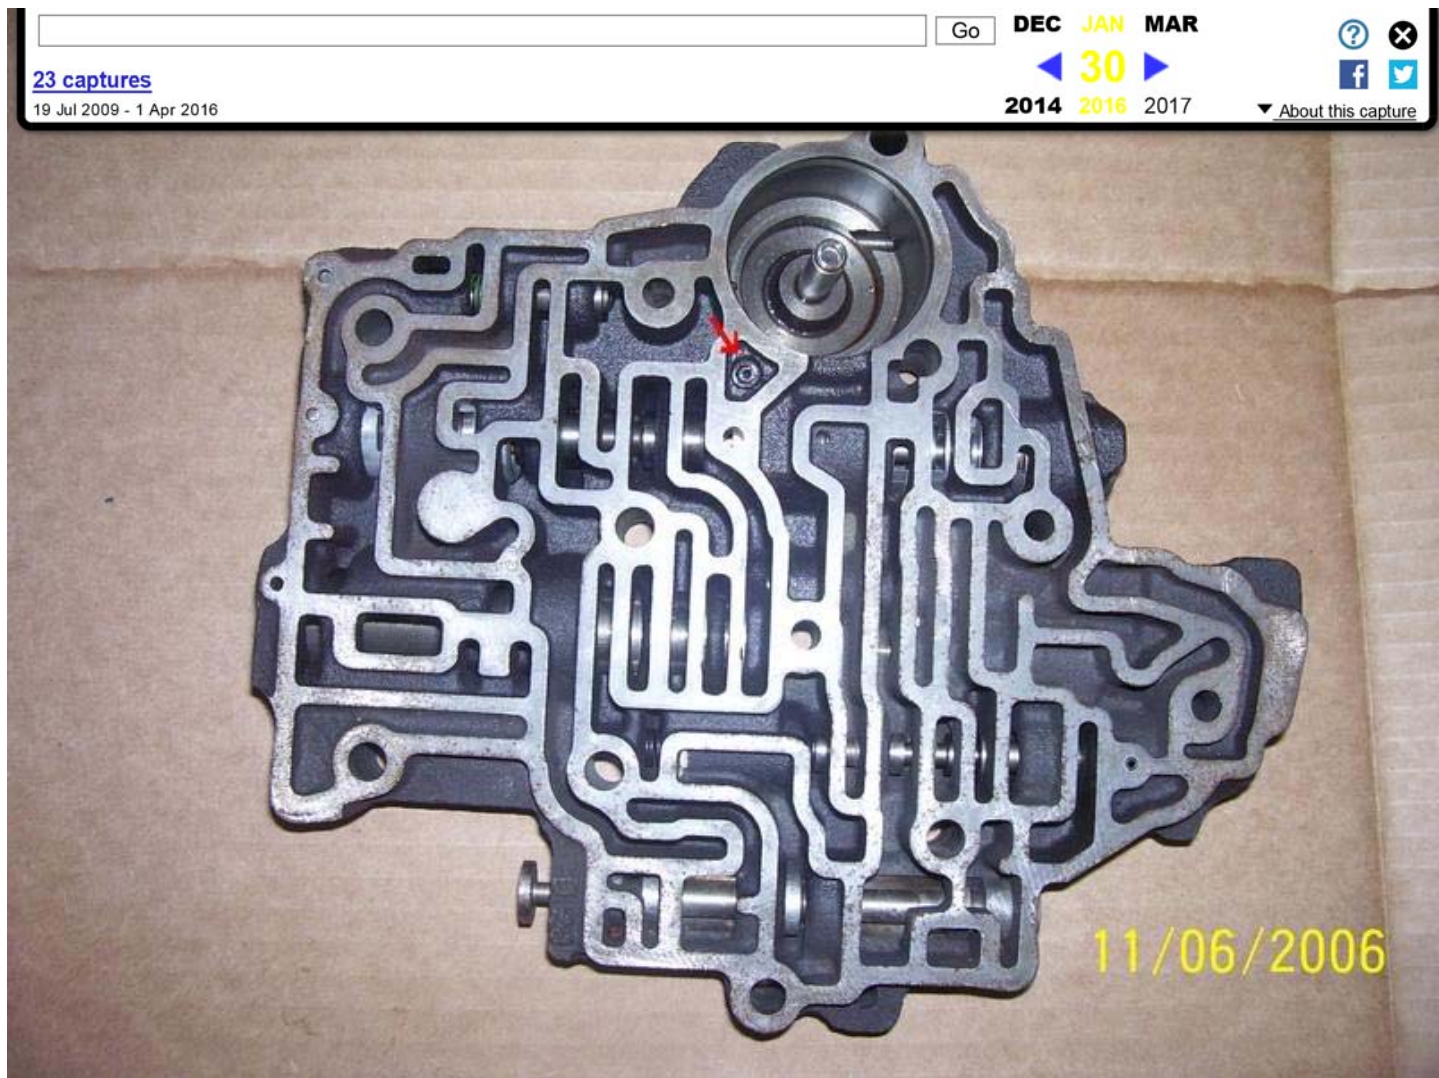
The photo below shows the set screw installed in the 3rd accumulator feed passage.

We recommend disassembling the 2-3 accumulator piston in the valve body (empty bore shown). Tapping the marked passage with a 5/16" tap and installing a 5/16 set screw.

You only need to tap the passage deep enough for the set screw to not protrude. This gives the set screw a place to tighten and seat.

You can omit the accumulator spring but you must re-install the piston. It becomes a travel limiter for the 2nd servo in the case.

This modification firms up the 2-3 shift, it will also affect the manual 1-2 shift.

We do this on most of our performance TH400 builds, however on 4x4 applications we typically leave the 3rd accumulator fully functional to prevent undue stress on the transfer case.

We recommend blocking the 2-3 accumulator as shown above in combination with dual feeding.

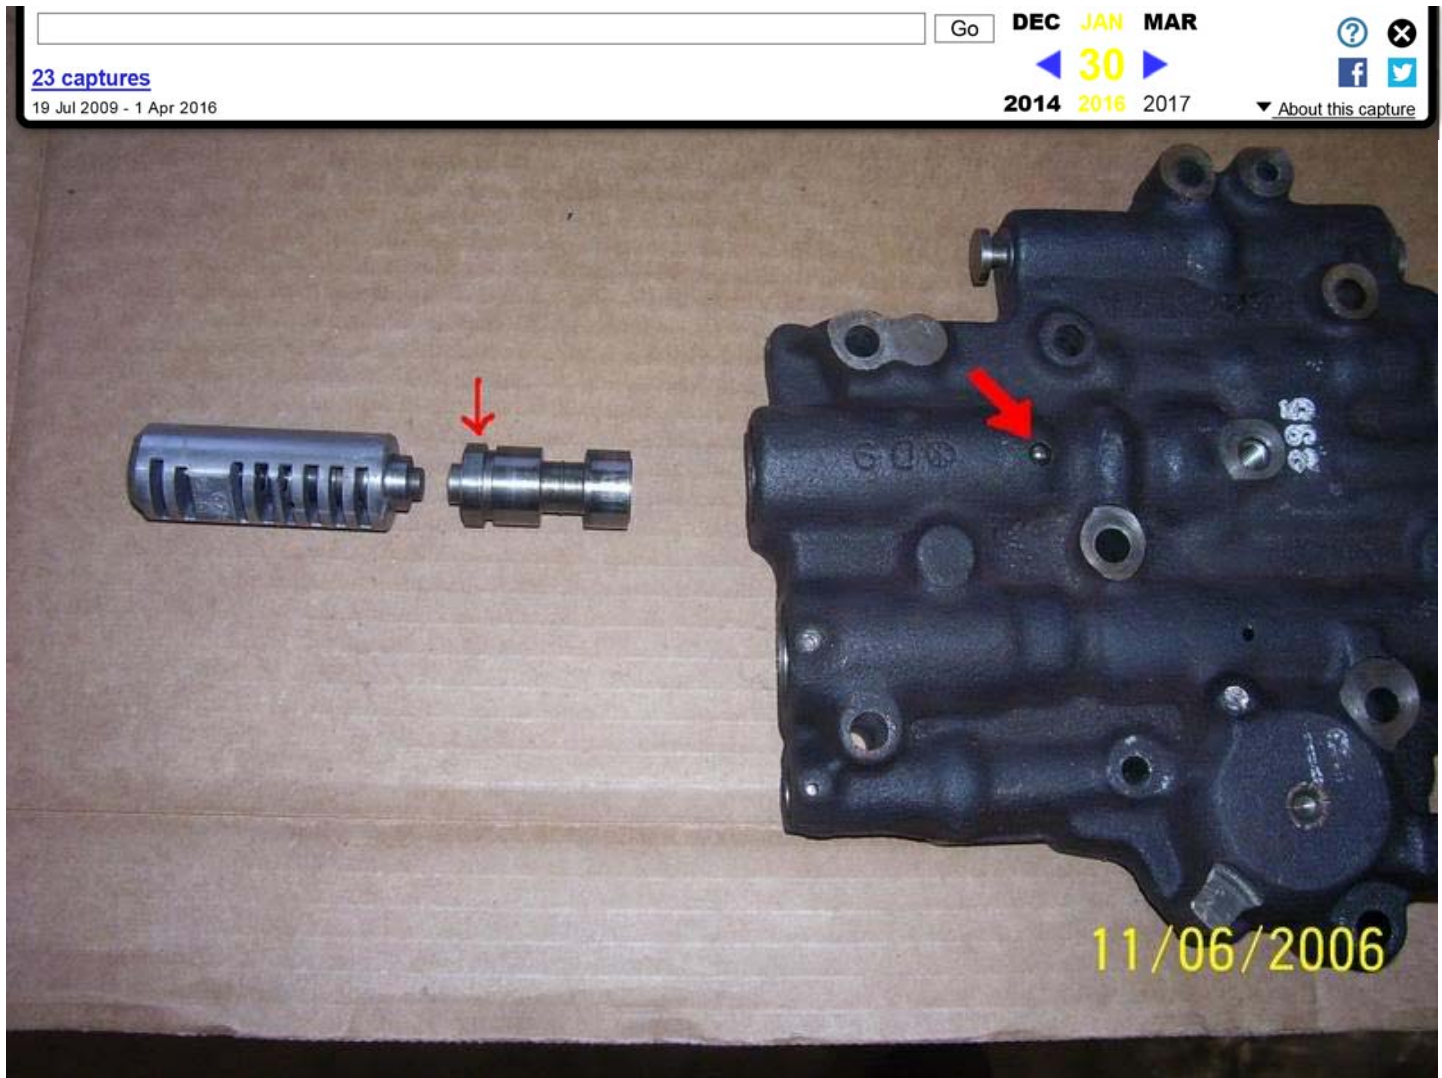
Shown below is the manual low control modification.

The 1-2 shift valve train is shown. Remove the roll pin in the end of the valve body, carefully remove the 1-2 valvetrain. A couple of awls or pocket screwdrivers are helpful. Pry the 1-2 shift valve (innermost or right side valve as seen in pic below.). It will help push the shift valve sleeve out of the bore.

Once you get it all out, you want to grind two flats on the 1-2 shift valve as seen in the pic, on the land marked with the arrow. Deburr any edges left from grinding.

There are several methods to plug the exhaust hole seen on the valve body. Shown is a checkball driven into the valve body casting. This is an effective method but care must be taken not to damage the valve body.

You must first drill the hole to 7/32" and it doesn't hurt to ream the hole a bit beyond that.

Reinstall the 1-2 shift valve in the bore to support the VB, now drive a checkball into the exhaust hole but don't drive it too far.

The key is that the 1-2 shift valve needs to be able to move freely in the bore.

Deburring the bore may be required after drilling and installing the checkball. A fine round file works well for this but don't get carried away.

You can also tap the hole and install a small set screw, or drive a cup plug in the hole if you can find a suitable size.

Once the 1-2 shift valve land has been ground, the exhaust hole plugged, and free movement of the 1-2 shift valve in its bore has been verified, reassemble the 1-2 shift valvetrain as it came apart.

You can now hold 1st gear to any speed or rpm, and you can also downshift to 1st from any speed. Be CAREFUL this mod has the potential to cause engine damage if you downshift from too high of a speed.

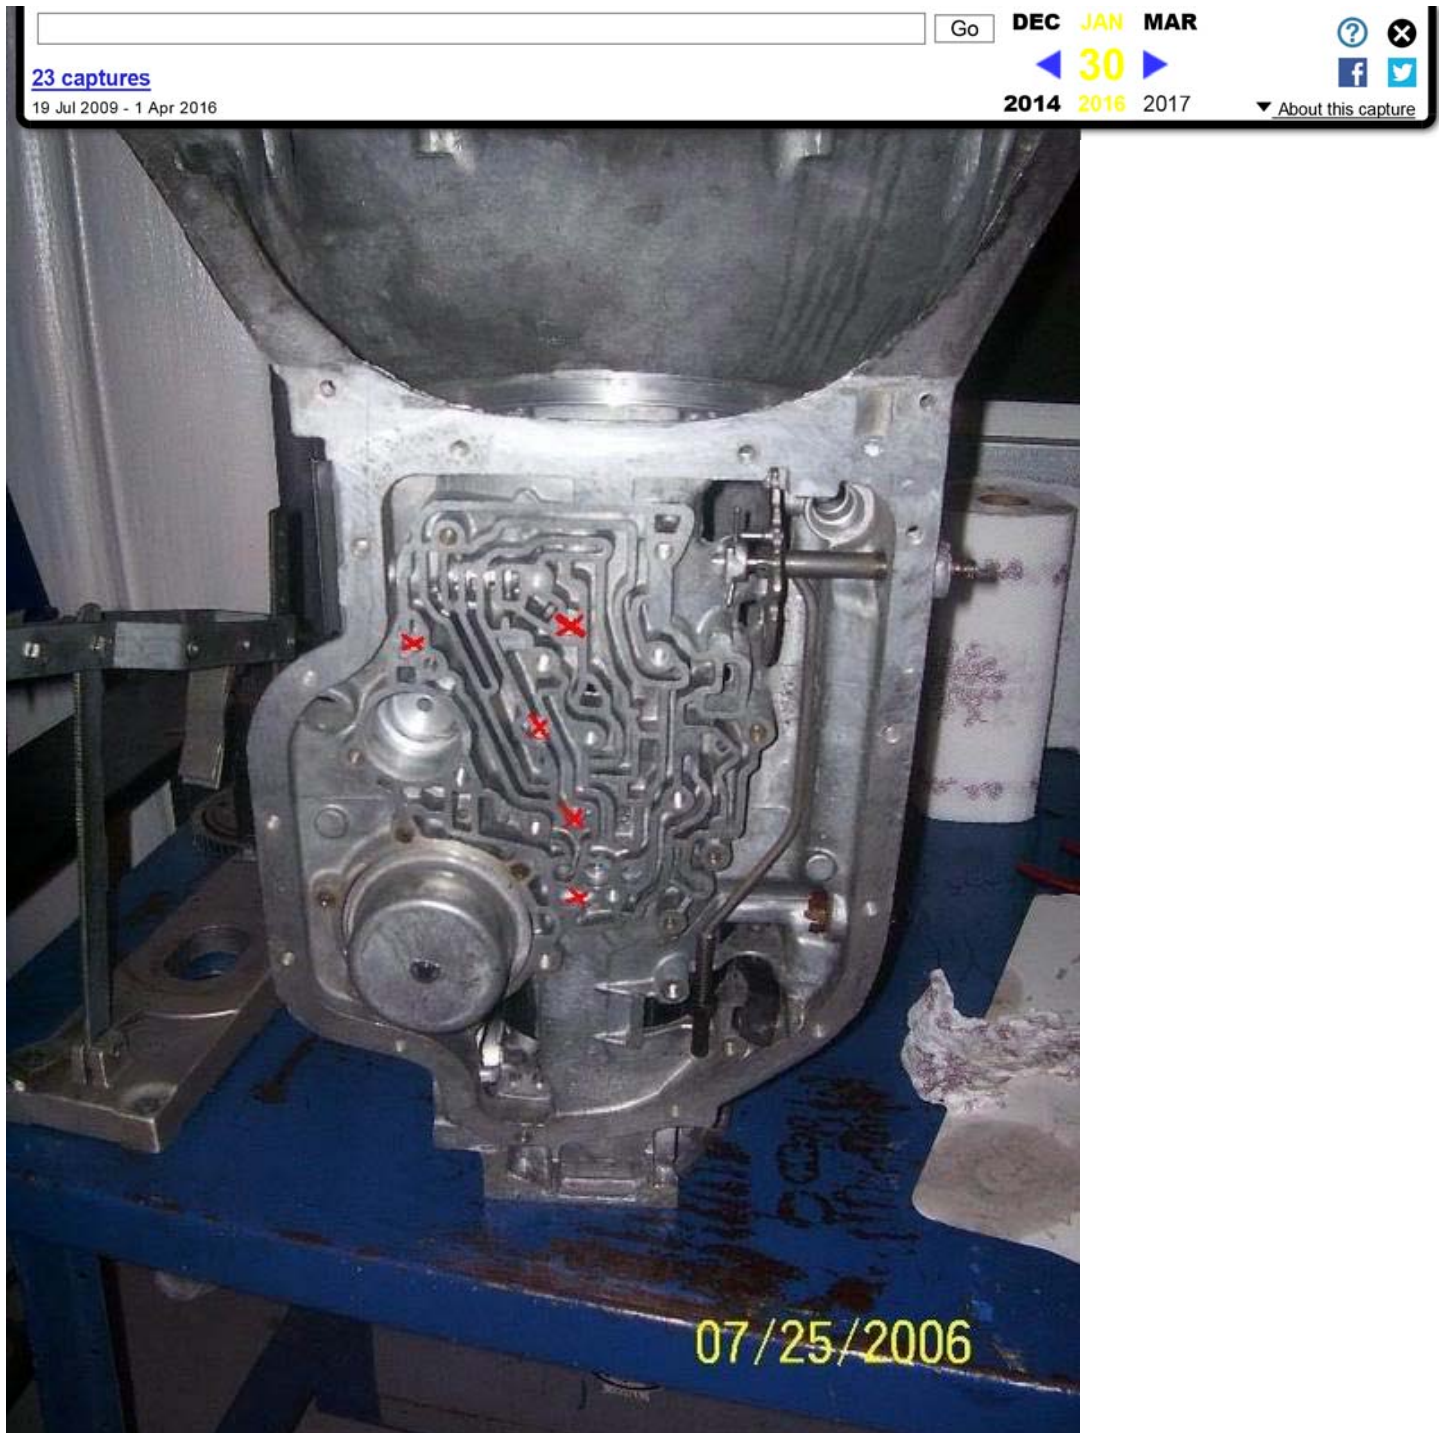
We typically retain 5 checkballs in the case for our automatic VB TH400s using the valve body modifications shown above.

They are shown here for reference. Some later cases (87-up) used an extra checkball. One checkball omitted is considered non-functional and left out on most stock rebuilds.

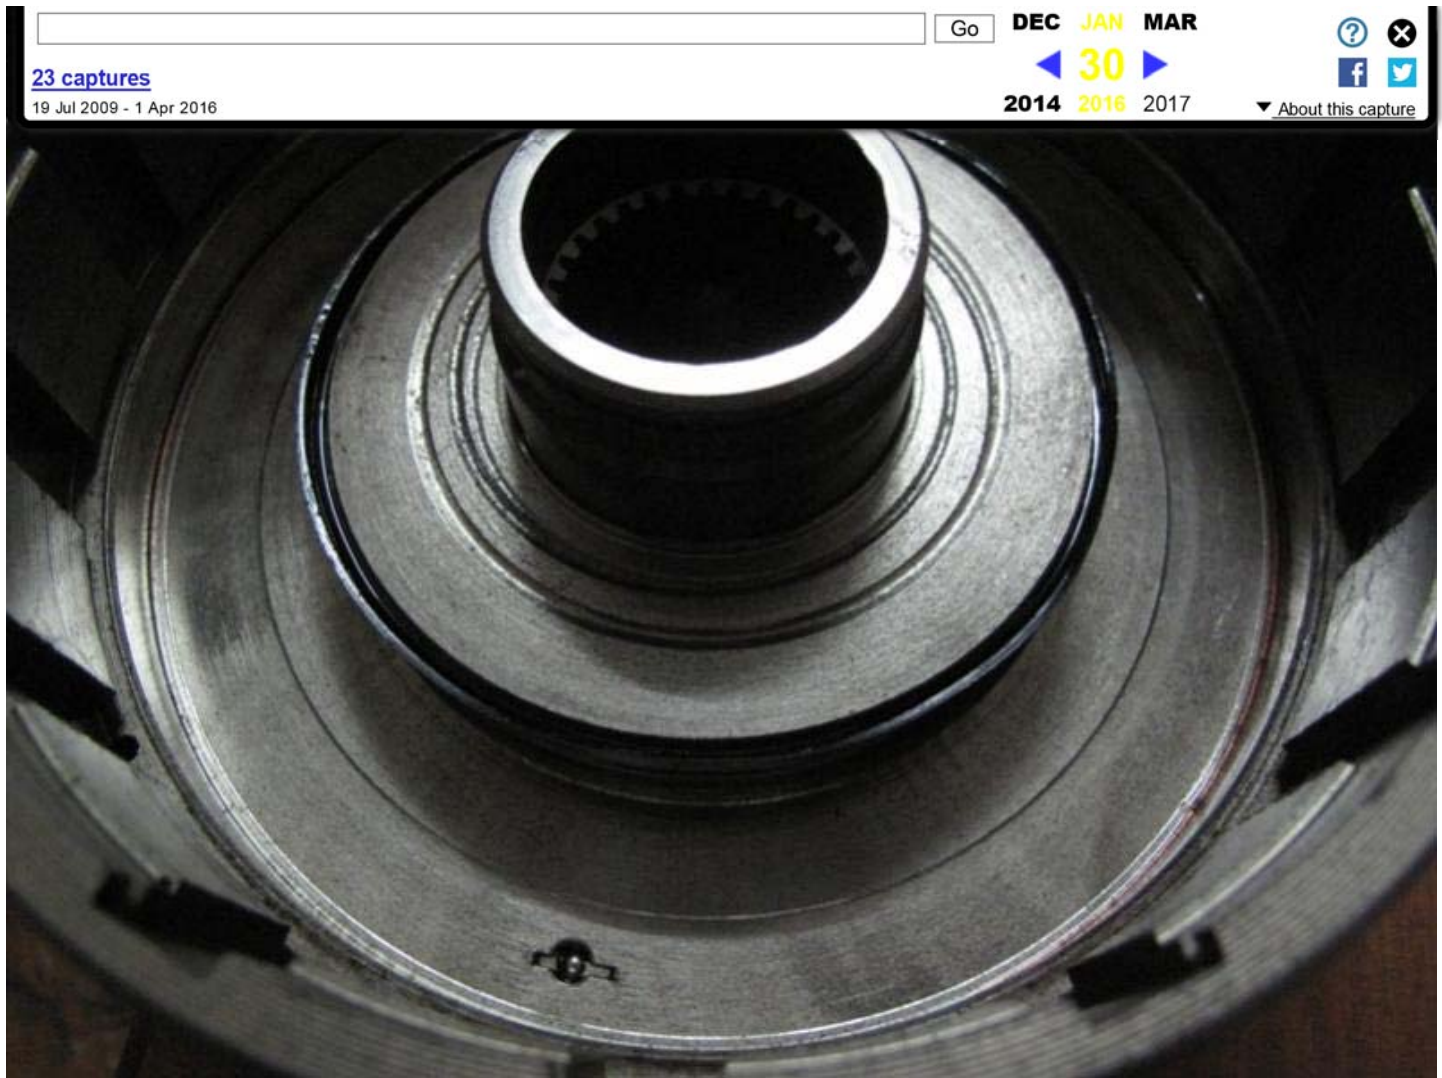
It requires removing the center seal from the direct drum. This is the only seal on the drum itself. You **MUST** retain both the inner and outer direct piston seals. The center seal separates the direct piston into two separate apply areas or chambers in the drum. By removing this seal you are making it one large apply area that yields much more apply pressure to the frictions.

The seal that needs to be removed is seen in the photo below. It is on the edge of the "stepped" area of the drum.

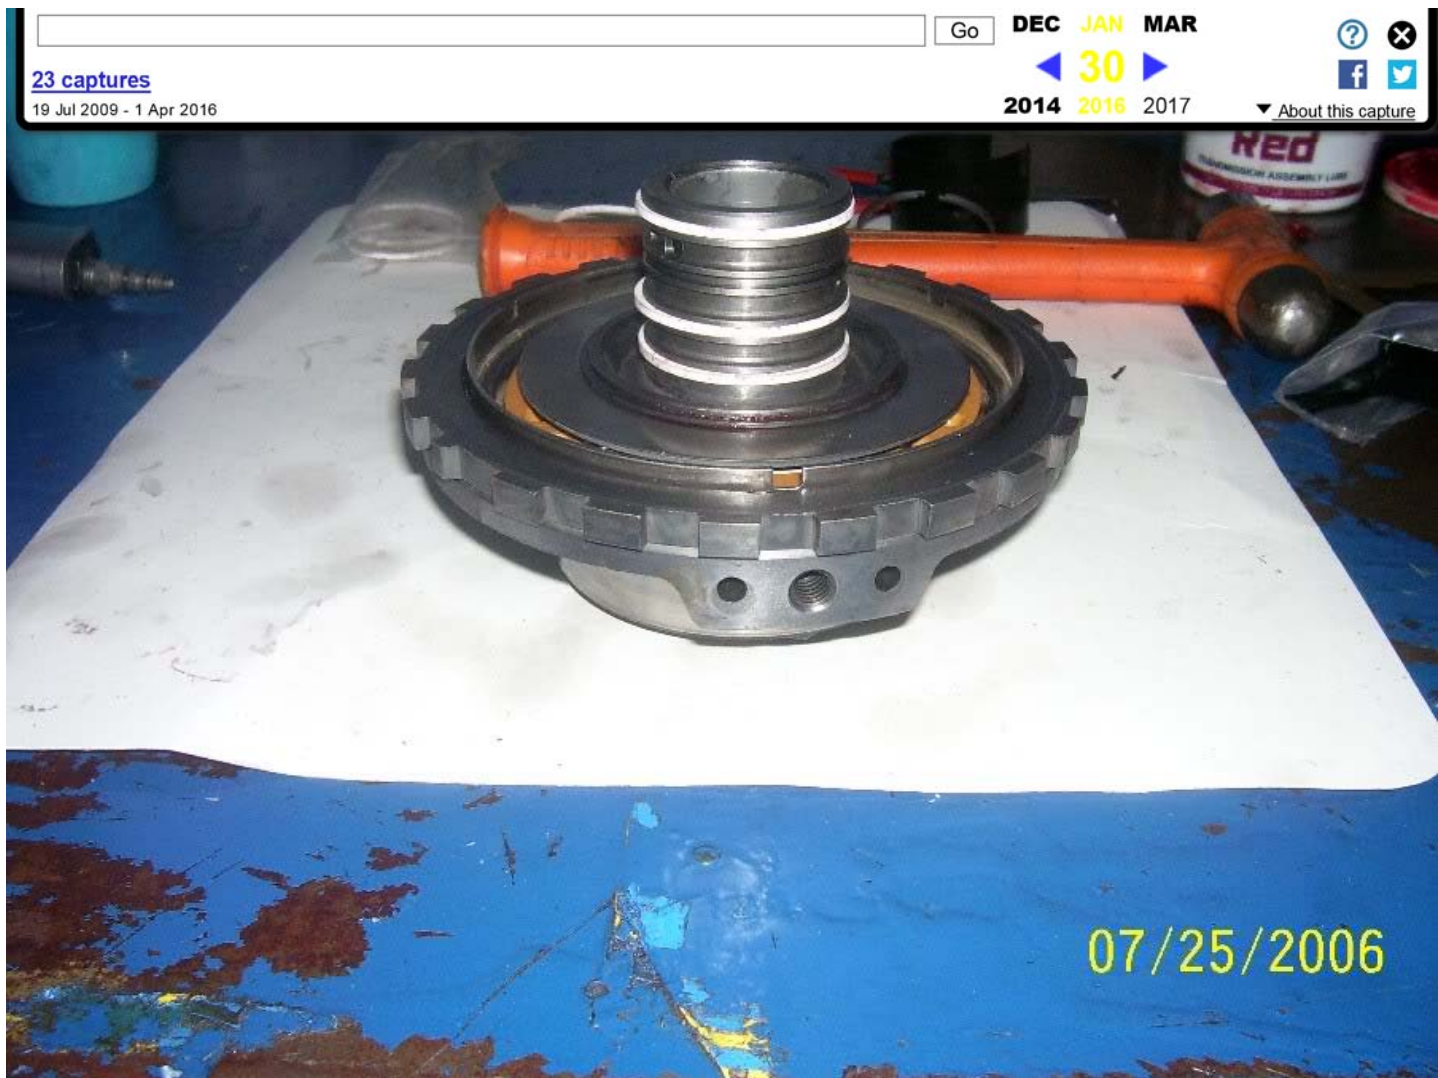
You can also remove the 2nd sealing ring on the center support. We prefer to do remove both the direct drum center seal and the center support second sealing ring. Technically you only have to remove one or the other to dual feed the clutches.

The center support sealing ring is shown below, notice the empty groove 2nd from the top.

The reverse feed is the hole shown on the far right in the pic above. 3rd feed is the leftmost hole, and the center hole that is threaded is the 2nd feed.

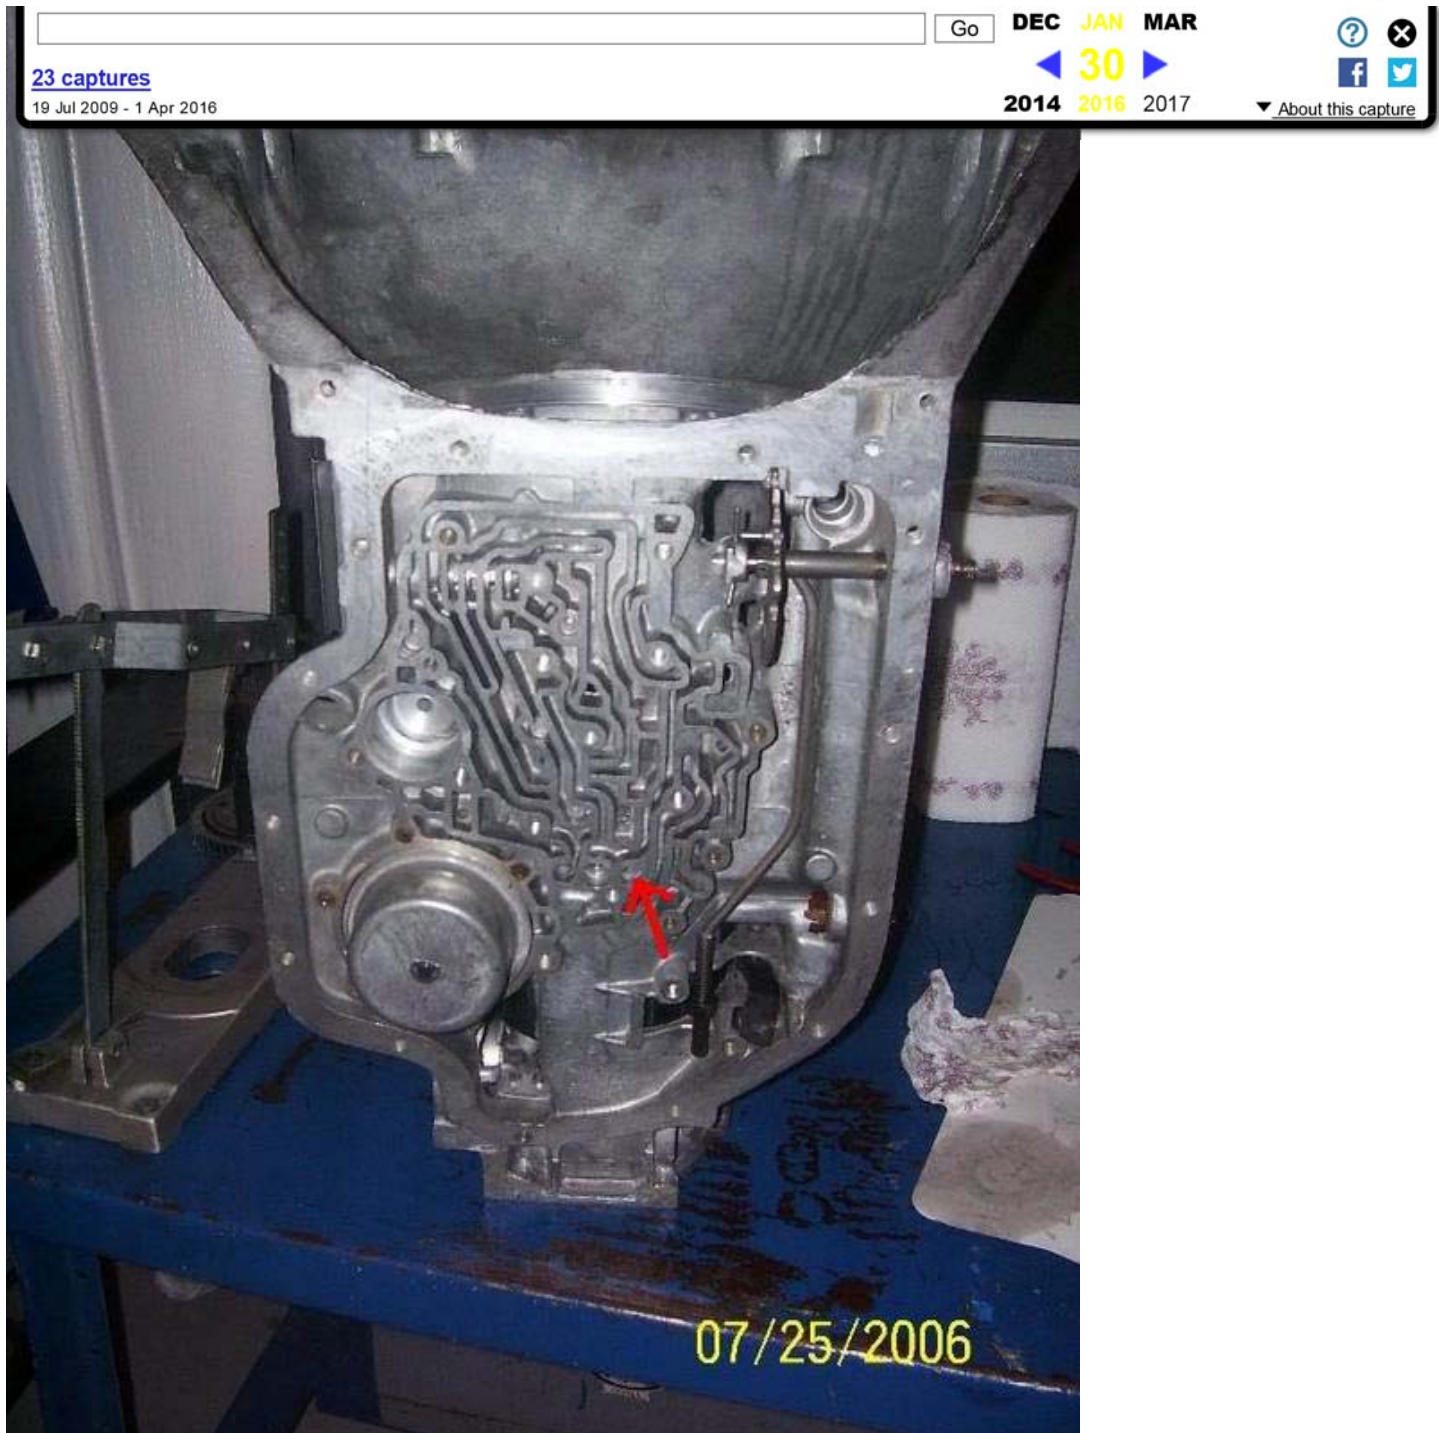
To correct the leak created by dual feeding, the reverse feed side of the center support must be plugged. That can be done in the center support itself by tapping the hole and installing a set screw or it can be done with a cup plug in the case at the reverse feed into the center support.

We typically install a 3/8" cup plug into the case at the location shown below.
