# **#90-335-6A: ENG. NO START AFTER EXTENDED STORAGE (VITON HOSE KIT) - (Aug 15, 1990)**

**Subject: ENGINE NO START AFTER EXTENDED STORAGE**

**Model and Year: 1990 TRUCKS WITH FUEL INJECTION AND 2.5L, 2.8L, 4.3L, 5.0L, 5.7L, 7.4L ENGINE**

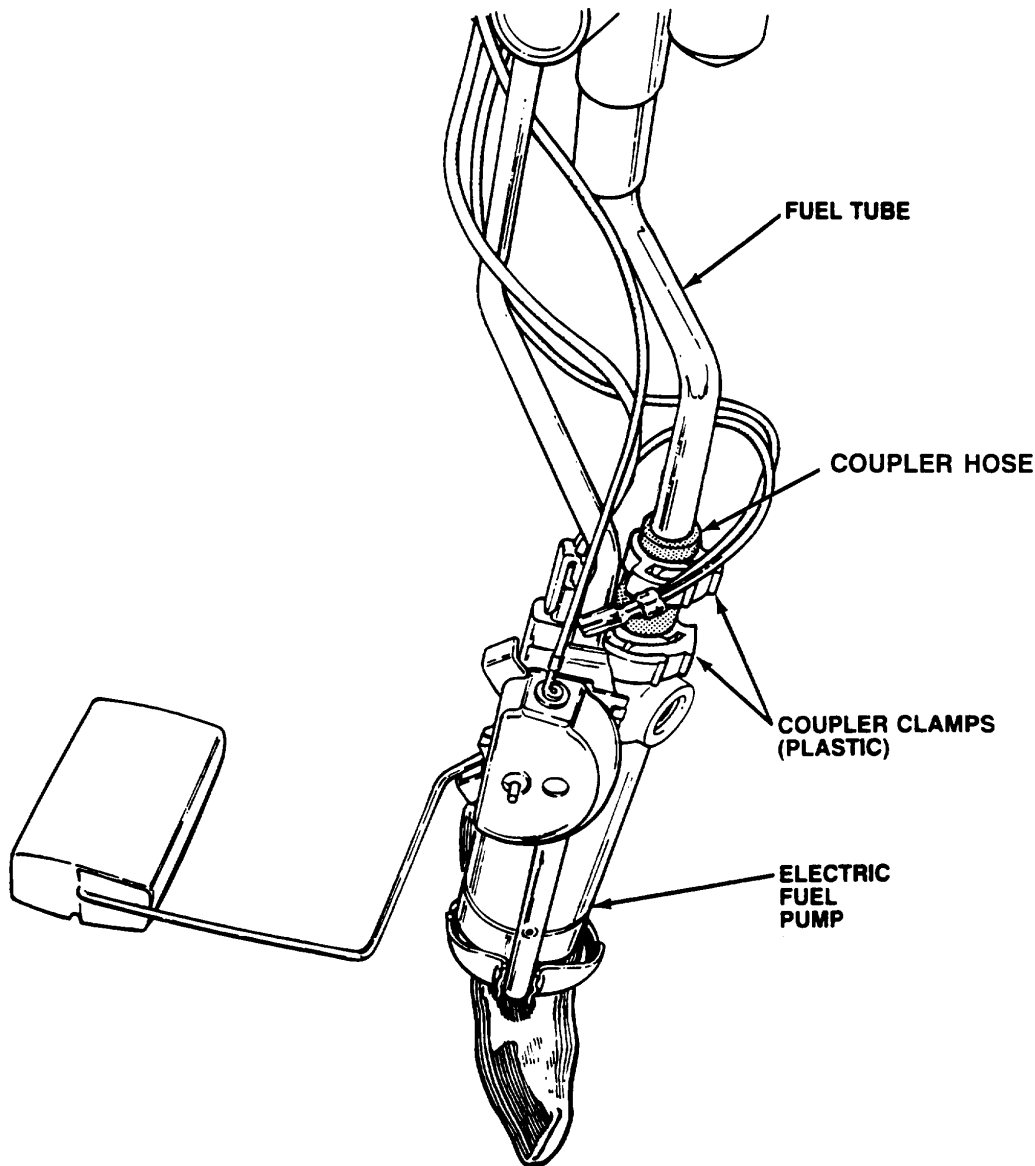
Figure No. 2

Some 1985-90 light trucks equipped with throttle body injection (TBI) engines (see list below) may experience a condition where fuel delivery to the engine is interrupted causing a no start. This condition may be caused by deterioration of the in-tank fuel pump coupler hose located between the sending unit assembly and the fuel pump. The deterioration is caused by prolonged high ambient temperatures in combination with low fuel volumes (or stale fuel) and extended vehicle storage.

Vehicles that are diagnosed as exhibiting this condition may be repaired by replacing the original coupler hose (see Figure 2) with a new Viton coupler hose kit, P/N 25028041. The kit consists of a new Viton hose and two clamps.
