GMC NUMBER:90-10-98

CORPORATE
NUMBER:061602
SUBJECT:WIND NOISE/COLD AIR
INTRUSION AT DOORS

MODELS:ALL 1985-86 C/K AND 1987-90
R/V TRUCKS

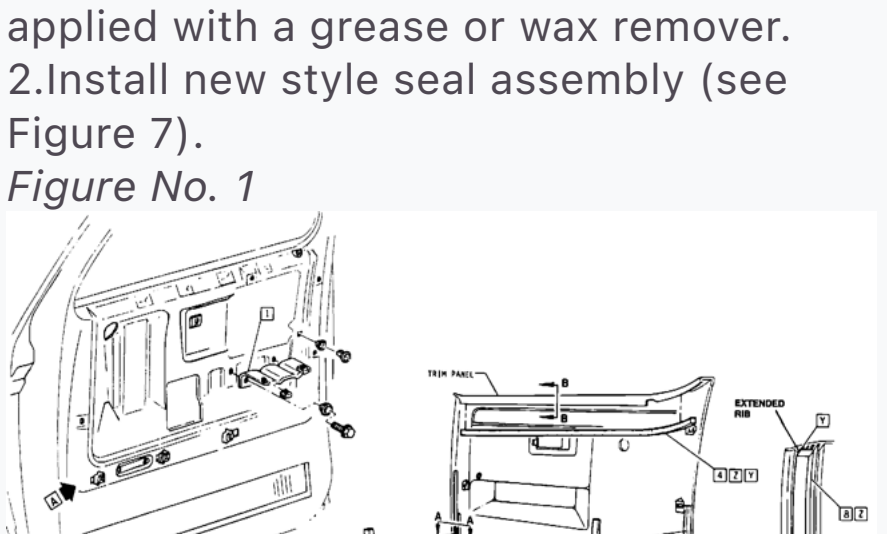
Figure 5 - Door Trim Pad Clip Remover

10.Remove door trim panel to door retainers using J24595-B (see Figure 5).

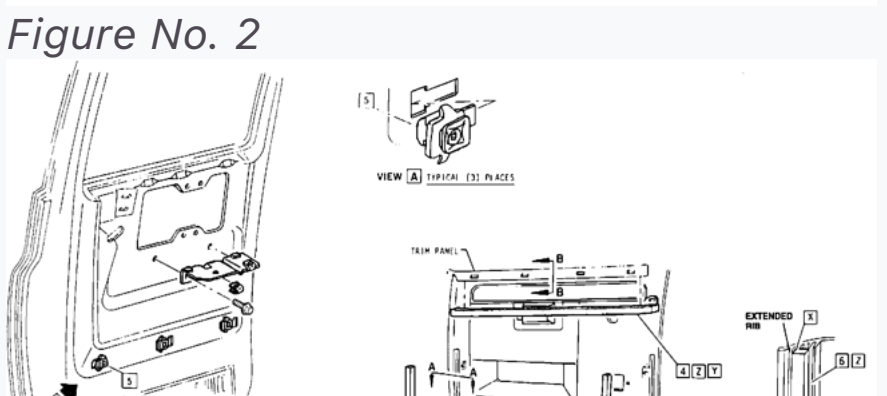
Figure 6 - Door Trim Panel Components

Remove or Disconnect (see Figures 3-6)
